Geomorphically Effective Floods

John E. Costa and Jim E. O'Connor

U.S. Geological Survey, Vancouver, Washington

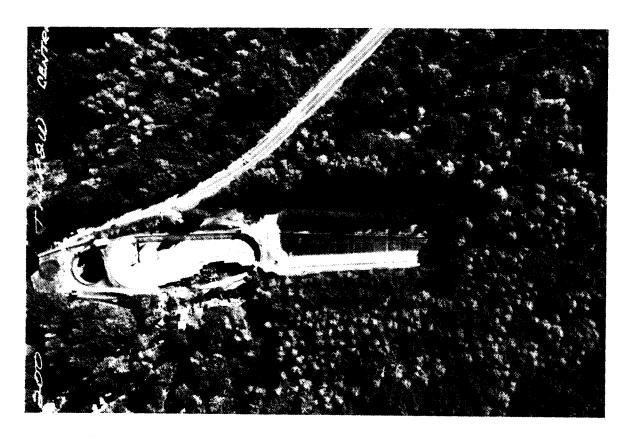
Fig. 2. Airphoto of the failure of Reservoir No. 3, Centralia, Wash. (from Costa, 1994).

Reservoir No. 3 is a small concrete-lined water-supply reservoir for the city of Centralia, Washington (Figure 1). On Oct. 5, 1991, the bedrock hillslope under the southwest side of the reservoir suddenly failed, and instantaneously released 13,250 m³ of water down a small steep valley that led to the eastern edge of the city of Centralia. Two houses were destroyed, four city blocks were flooded, and 400 people were evacuated (Figure 2) [Costa, 1994].

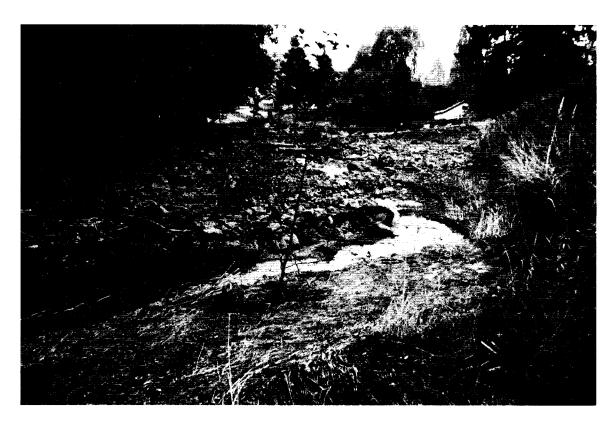
Fig. 3. Photograph of the floodplain below Reservoir No. 3, Centralia, Wash., where there was only minimal damage from the flood.

A four-section slope-area indirect discharge estimate was made on Oct. 10, 1991, five days after the dam failure, at a site 275 m below the emptied reservoir (Figure 3). Scour and deposition, a steep channel slope of 0.09, and uncertain roughness coefficients all contribute to some uncertainty in the final peak-discharge estimate of 71 m³/s. An official for the city of Centralia, responsible for the operation of the reservoir, reported that the reservoir drained in three to five minutes. At a constant discharge rate of 71 m³/s, it would take 3.1 minutes to drain the

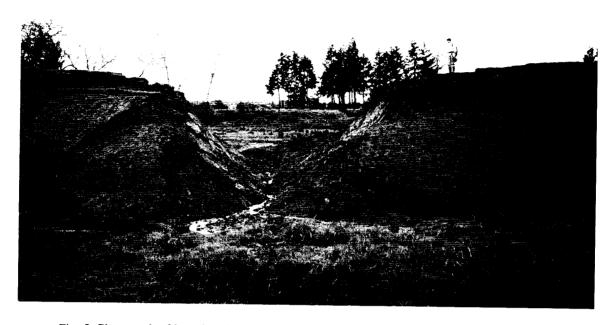
Fig. 5. Photograph of breach and slump failure of the Porter Hill dam, near Roseburg, Oregon.

The Porter Hill dam was 5.8 m high, about 20 m wide, and stored an estimated 15,000 m³ of water at the time of failure. The earthen dam was constructed of local clayey residuum. The exact date of the dam failure is unknown, but it is believed to have failed on or about February 27, 1993 (John Falk, Oregon State Dam Safety Coordinator, personal communication, April 15, 1993). The dam apparently failed during a rainstorm when a large slump on the downstream face of the dam opened a breach with a top width of about 20 m (Figure 5). The large slump led to a near instantaneous failure of the dam, and the release of about 15,000 m³ of water down a steep upland valley.

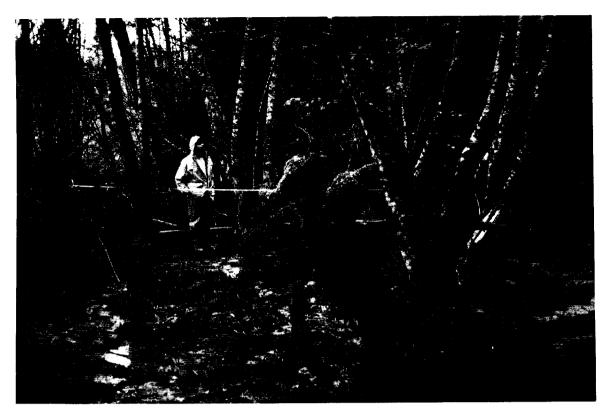
Fig. 6. Photograph of the channel and floodplain about 100 m downstream from the Porter Hill dam. Note the complete lack of any identifying evidence that a large flood had ever passed this location. The tape marks the maximum flood stage.

Peak discharge from the dam failure was estimated to have been about 30 m³/s at a location about 150 m downstream from the dam, using the slope-conveyance method (Figure 6). If a triangular-shaped hydrograph is assumed, considering the 15,000 m³ reservoir volume and the 30 m³/s peak discharge, the duration of the flood past the slope-conveyance site would be about 16.6 minutes. A reconstructed hydrograph for the flood is shown in Figure 4. Data for the two dams are summarized in Table 1.

At Porter Hill, the floodplain slopes at about 0.10 and consists of open forest and moss-covered stumps. The surface is covered with leaf litter, ferns, and a few fallen trees. Floodplain sediment consists of poorly-drained and unstratified gravel, silt, and clay. Following the flood at Porter Hill, moss was still intact on the upstream side of trees below high-water marks, and ferns and leaf litter were virtually undisturbed. It was nearly impossible to tell that a large flood, 10 m wide, and 1 m deep, had recently

passed at about 3 m/s (Figure 6).

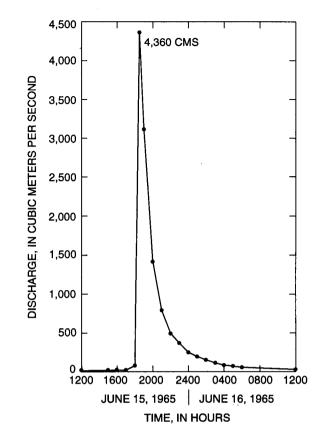
Fig. 7. Hydrograph for the Plum Creek, Colo. flood of June, 1965 (from Osterkamp and Costa, 1987).

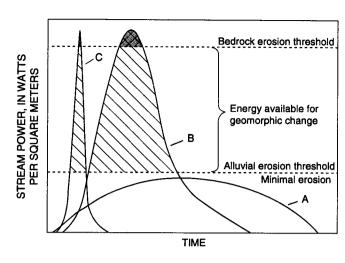
Fig. 11. Conceptual stream-power graphs used to document geomorphic effectiveness of different kinds of floods.

The ability to compute the distribution of stream power per unit area of a flood throughout the hydrograph, combined with consideration of potential landsurface resistance thresholds, allows us to construct a conceptual model of geomorphically effective floods (Figure 11). Three hypothetical stream-power graphs are plotted in Figure 11. Curve A represents a flood of long duration but very low peak stream power. Total energy generated by the flood at a particular site, represented by the area under the stream-power graph, may be large. But in spite of a large total energy expenditure, and long flow duration, peak stream power never rises above the threshold required to significantly disrupt alluvial channels and floodplains. There has been some effort to identify minimum thresholds of critical stream power and boundary shear stress for alluvial systems, but far more work in a variety of environments is required [Magilligan, 1992; Prosser and Slade, 1994]. Great floods along large, low-gradient rivers such as the Mississippi River flood of 1927, which

generated peak stream power per unit area of about 12 W/m², would be representative of curve A.

Curve B represents large floods that generate high values of peak stream power per unit area, and have moderate to long duration. Average flood stream power per unit area is high, and total energy expended by the flood is large. Peak stream power per unit area can be great enough to generate processes capable of eroding some bedrock boundaries, such as cavitation or macroturbulance [Baker and Costa, 1987; O'Connor, 1993]. Tremendous changes in alluvial channels are possible, even total unraveling of floodplains, because of the large energy expenditure represented by the area under the stream-power graph above the alluvial threshold. Area above the bedrock threshold represents the amount of energy available to erode and effectively modify bedrock flood-channel boundaries. Floods represented by curve B are likely to be the most geomorphically effective fluvial events in any landscape, and would include exceptional floods like the Rubicon River and Teton River dam-failure floods, and colossal paleofloods like the Missoula and Bonneville floods [O'Connor and Baker, 1992; O'Connor, 1993].

Stream-power graph C represents floods that generate high values of instantaneous peak stream power per unit area, but are short-lived. The energy represented by the area under the stream-power graph above the alluvial threshold is small, and these floods are impotent to accomplish any significant amount of geomorphic change, even though instantaneous peak stream power per unit area may be among the highest values documented and well above landscape resistance thresholds. Total energy represented by the area under the curve above the bedrock threshold is also small, and the flood engenders little or no

perceptible change in alluvial or bedrock channels, even though instantaneous peak stream power per unit area may be comparable to other floods that eroded and shaped bedrock channels. These kinds of stream-power graphs are representative of flash floods in small basins that rise quickly and are gone in a matter of minutes. Such floods are generally caused by cloudburst rainstorms or the rapid failure of natural or constructed dams such as Reservoir No. 3 in Centralia, Washington, or the Porter Hill dam in Oregon.
